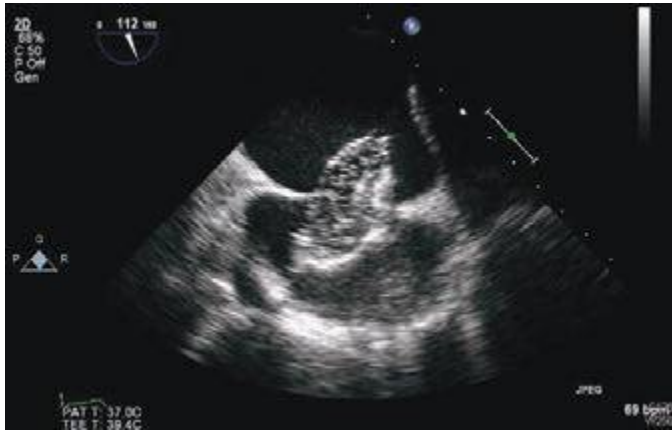
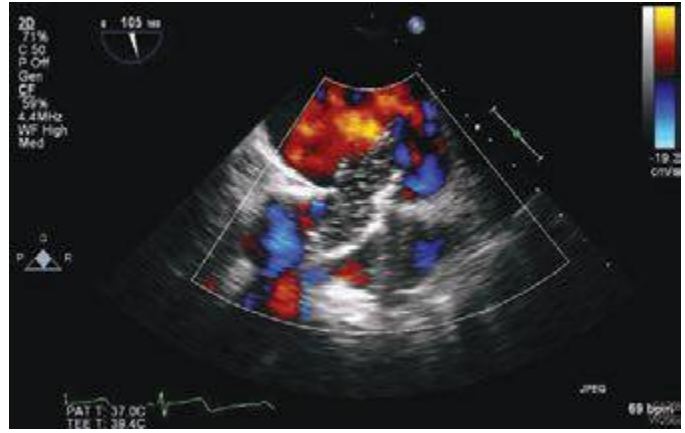
FIGURE 297e-19 Transesophageal echocardiogram showing sizing balloon (*left*) and no flow (*right*) across the atrial septal defect.

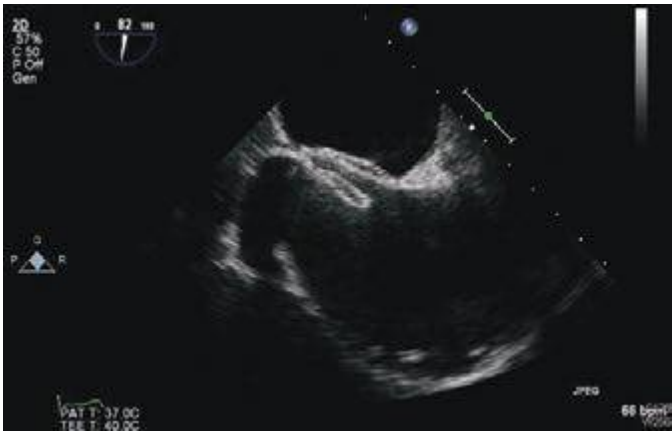
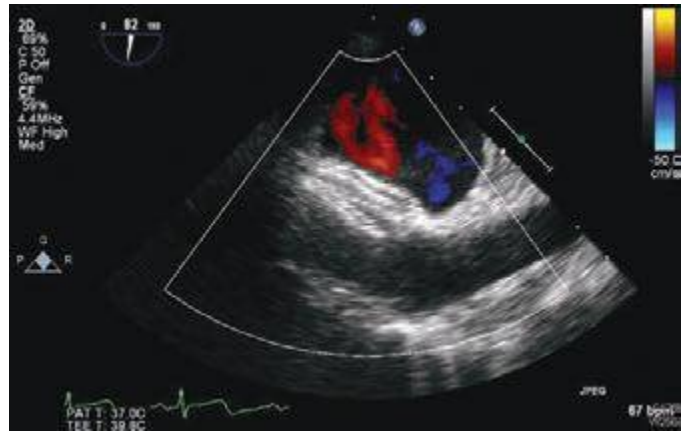
FIGURE 297e-20 Amplatzer® septal occluder in place (*left*). There is no blood flow across the device (*right*).

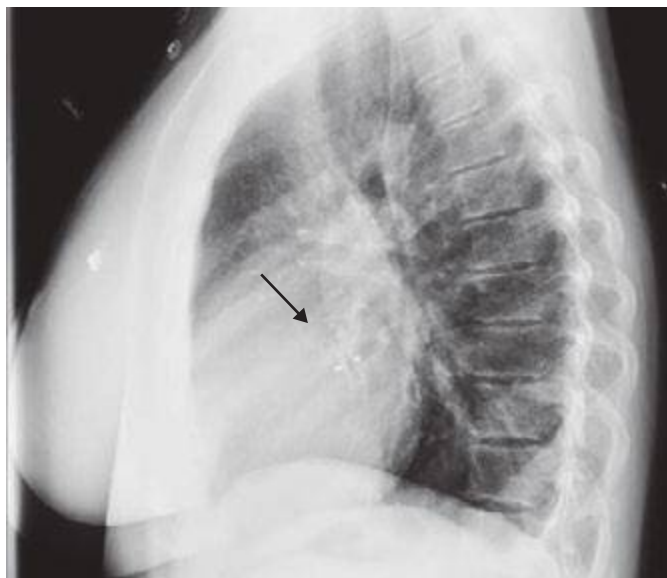
FIGURE 297e-21 Postprocedure lateral chest x-ray showing the Amplatzer® septal occluder in place.
