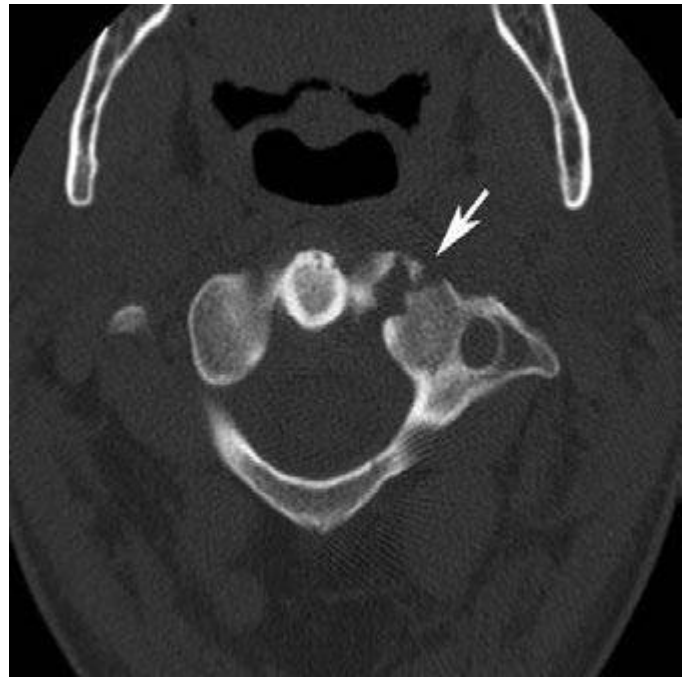
**FIGURE 441e-31** **CT facet fracture.** Axial CT demonstrates fracture line along the C2 facet (*arrow*).

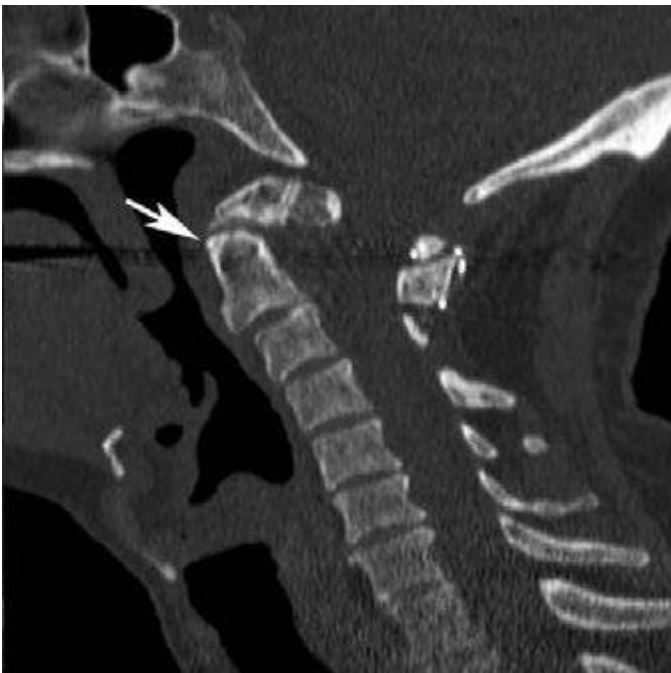
**FIGURE 441e-30** **Anterior dens dislocation.** Sagittal CT demonstrates the tip of the dens below the anterior arch of C2 (*arrow*), indicating anterior dislocation.

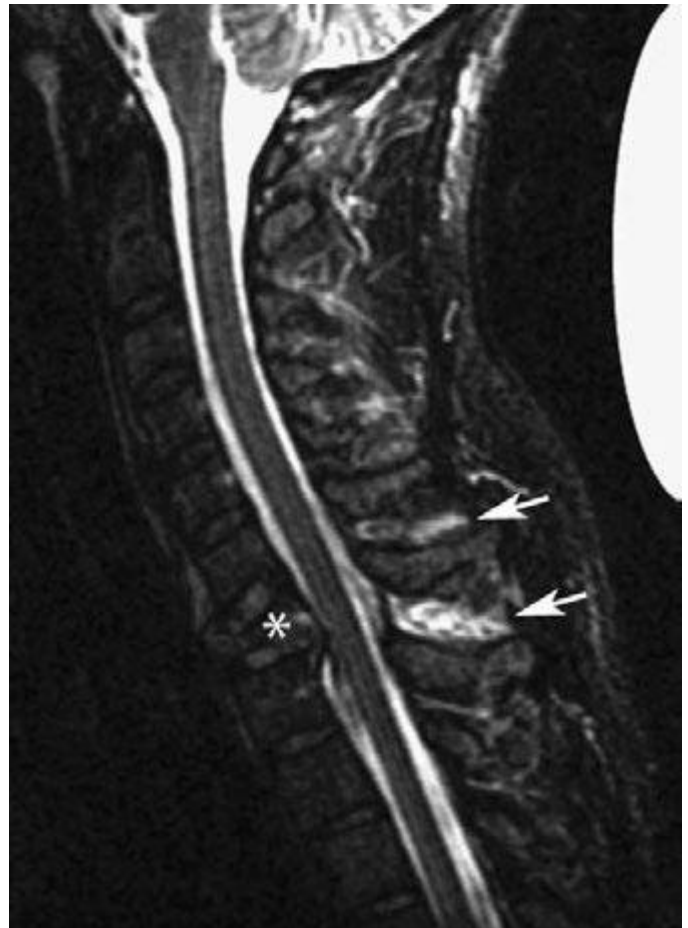
**FIGURE 441e-32** **Compression fracture.** Sagittal T2-weighted MRI demonstrates compression fracture of C7 (\*) and high signal within the spinous processes of C6-C7 (*arrows*) and to lesser degree C5-C6. This is suggestive of interspinous ligament injury. Note the pad under the patient's neck to maintain neck alignment during the scanning time.
