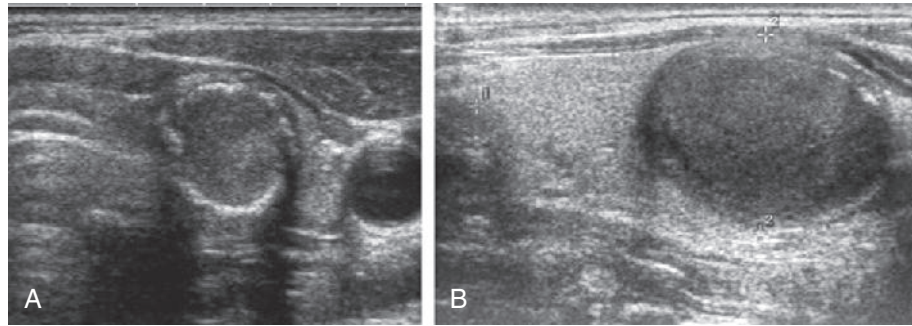
E-FIGURE 63-3 Ultrasound images of thyroid nodules. **A**, Transverse image of left thyroid lobe shows a complete thin rim of calcification encircling a thyroid nodule (eggshell calcification). **B**, Longitudinal image of a benign thyroid nodule in a different patient shows an incomplete, delicate thin rim of calcification at the inferior pole of a nodule proven to represent a benign hemorrhagic cyst. (From Desser TS, Kamaya A: Ultrasound of thyroid nodules, *Neuroimaging Clin N A* 18:463–478, 2008.)
